**WOODLAND HERITAGE SERVICES LTD
STAGE TWO PROJECT REPORT**

**STAGE 2 ARCHAEOLOGICAL AND CULTURAL HERITAGE ASSESSMENT
GOLDCORP CANADA LTD. – PORCUPINE GOLD MINES, HOLLINGER PROJECT
PRE-FEASIBILITY ENVIRONMENTAL BASELINE STUDY
TIMMINS, ONTARIO**

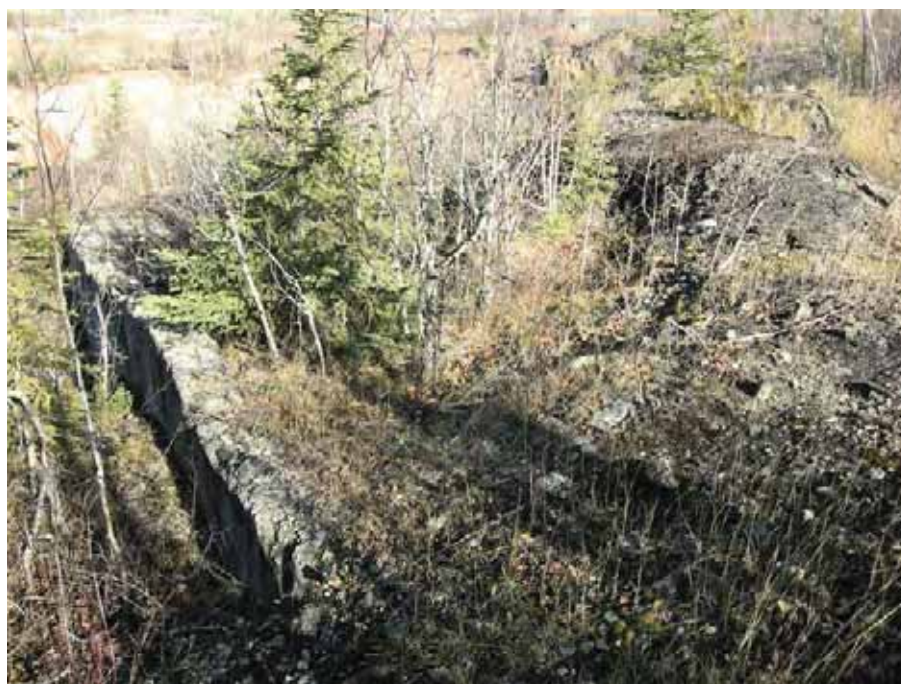
Figure 2.6. Photograph of the remains of the Directors' Lodge.

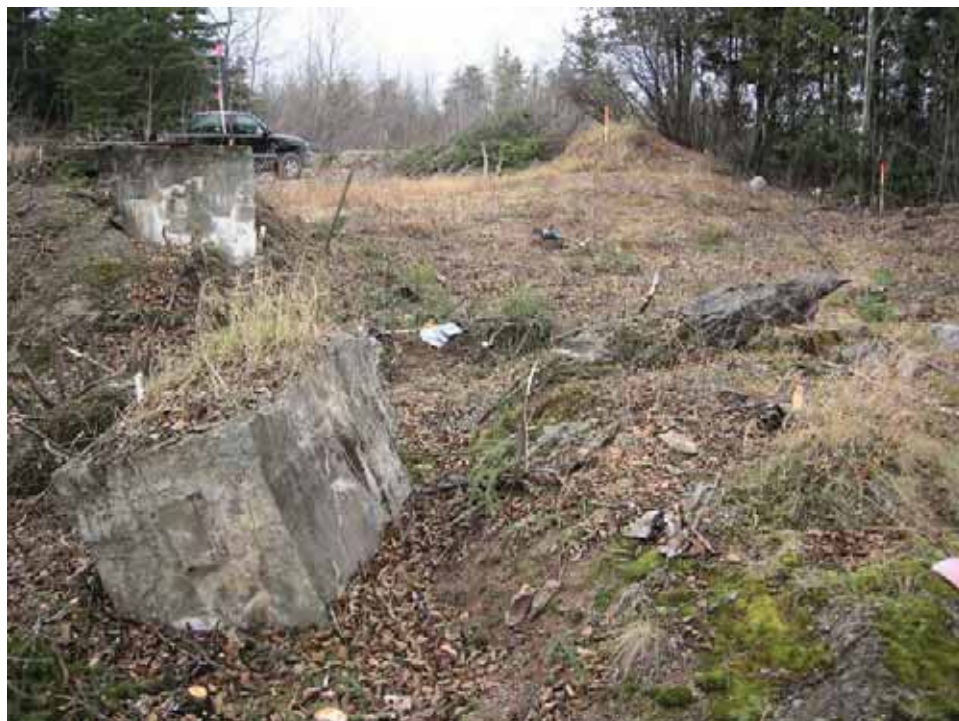
Figure 2.13. Photograph of two piers of the Manager's House foundation.

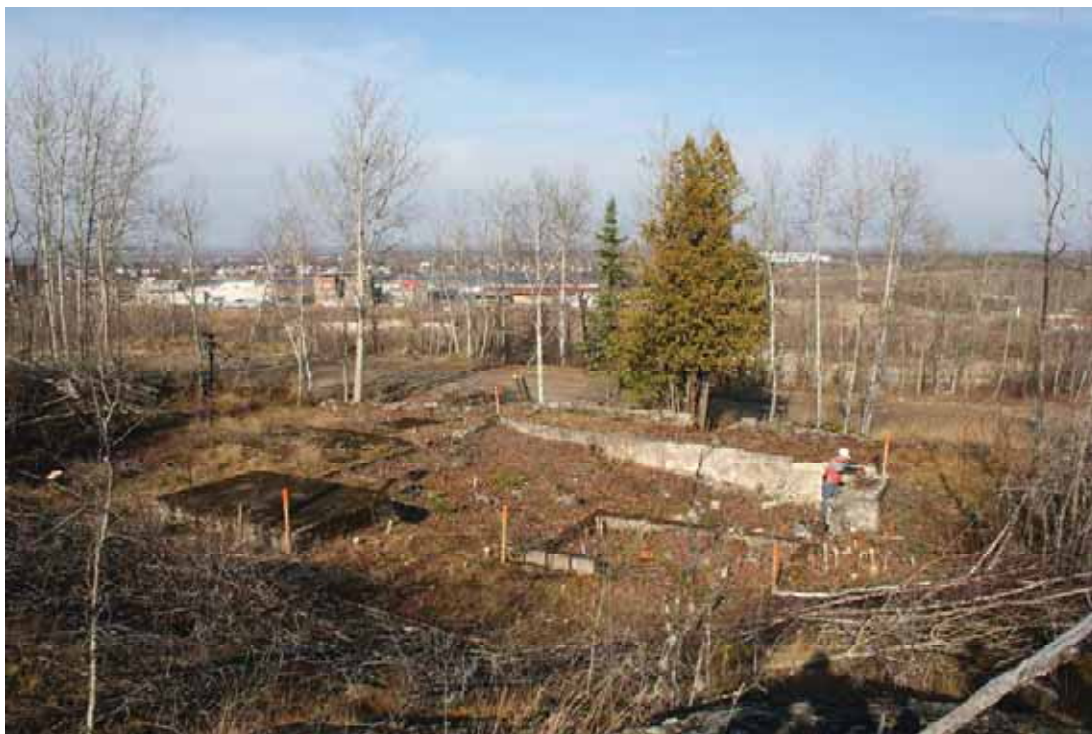
Figure 2.16. Photograph of the foundation of the Stone Wall residence.

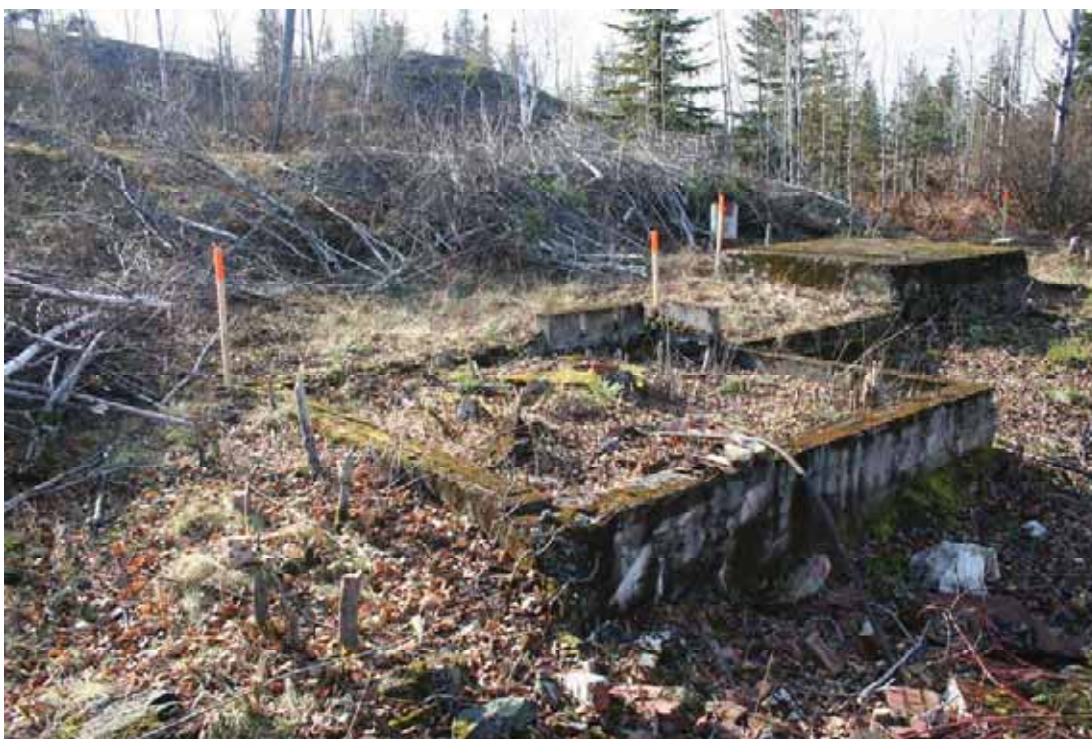
Figure 2.17. Photograph of kitchen/bath foundation.

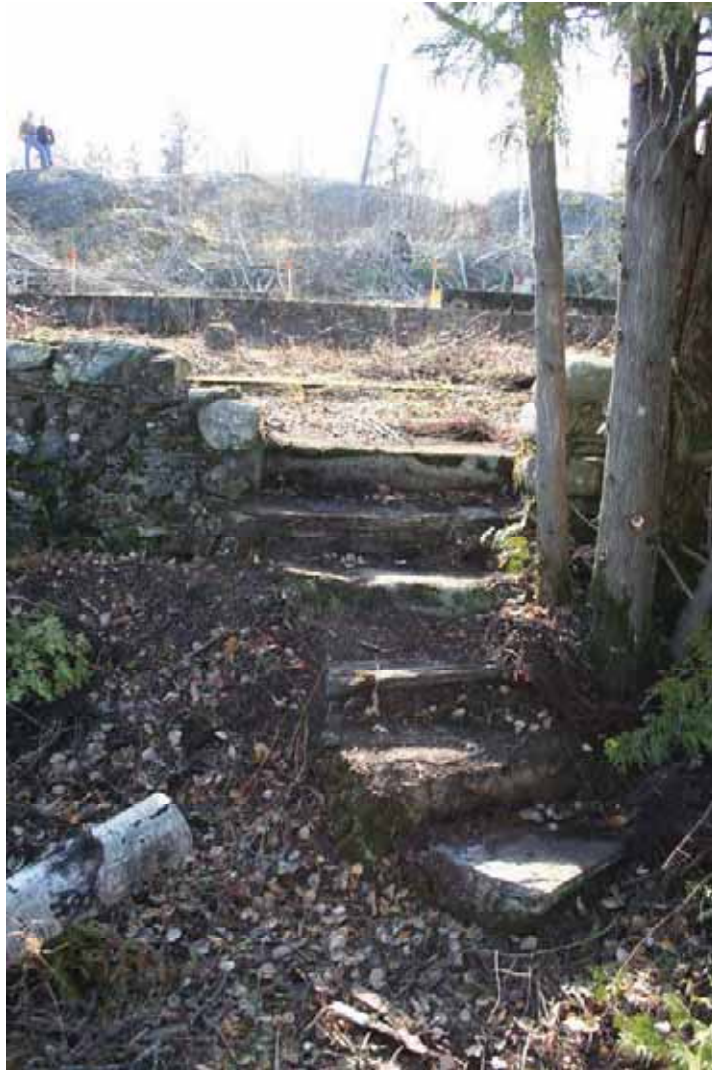
Figure 2.18. A photograph of the stairs leading from the pathway to into the centre area of the Stone Wall residence. Beyond this first wall is a poured concrete patio with a garden area in front of the house.

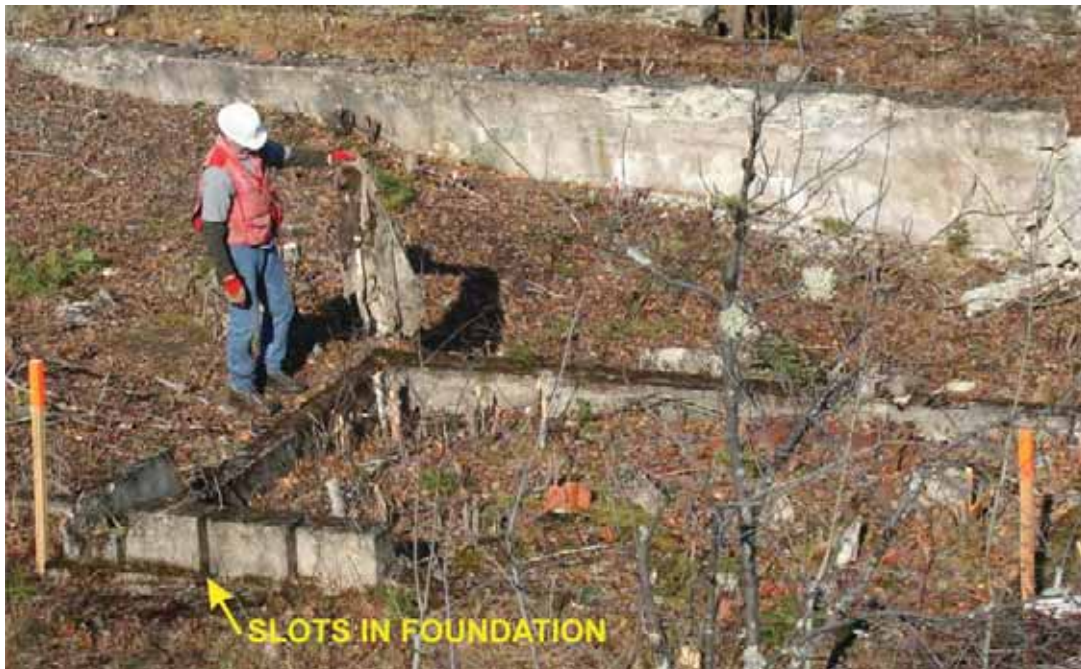
Figure 2.26. Slots in part of the foundation of the Stone Wall residence.

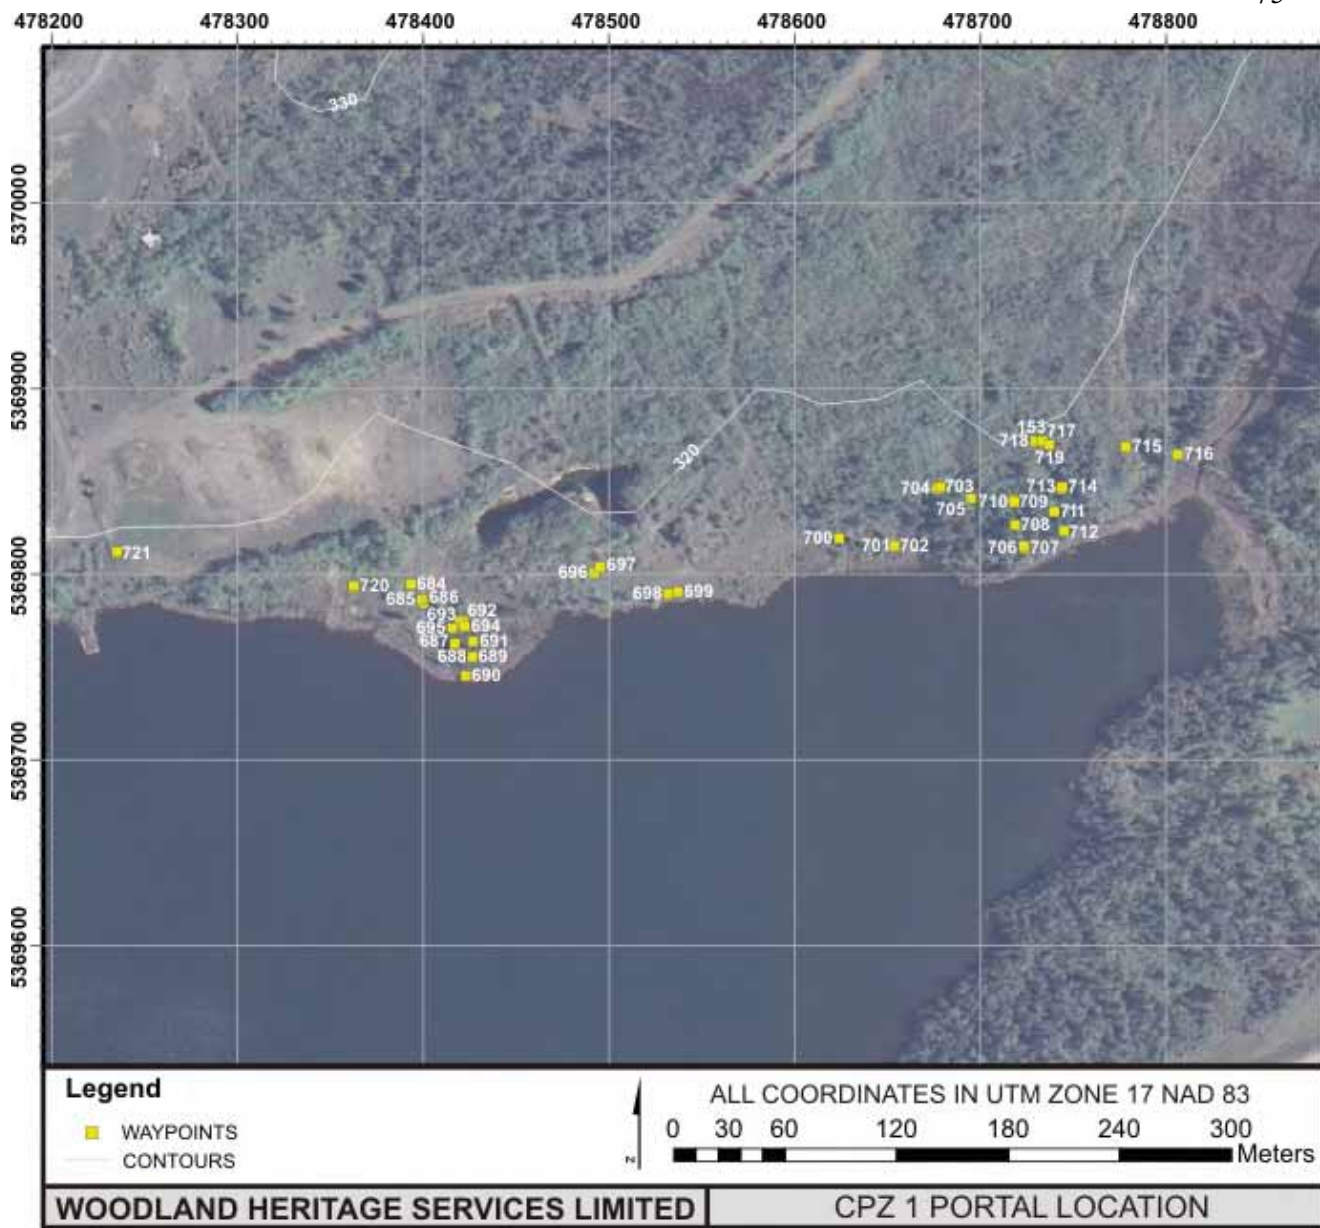
Figure 2.28. Satellite map of the waypoints taken at CPZ1.

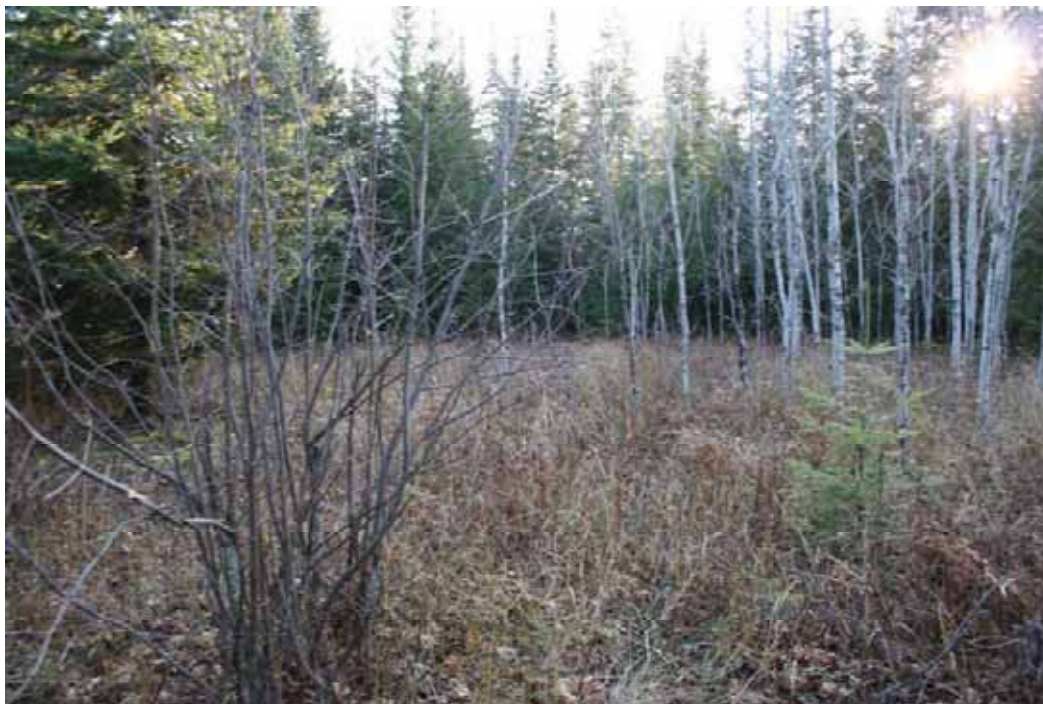
Figure 2.34. Photograph of CPZ1 area clearing where the domestic artifacts were found.

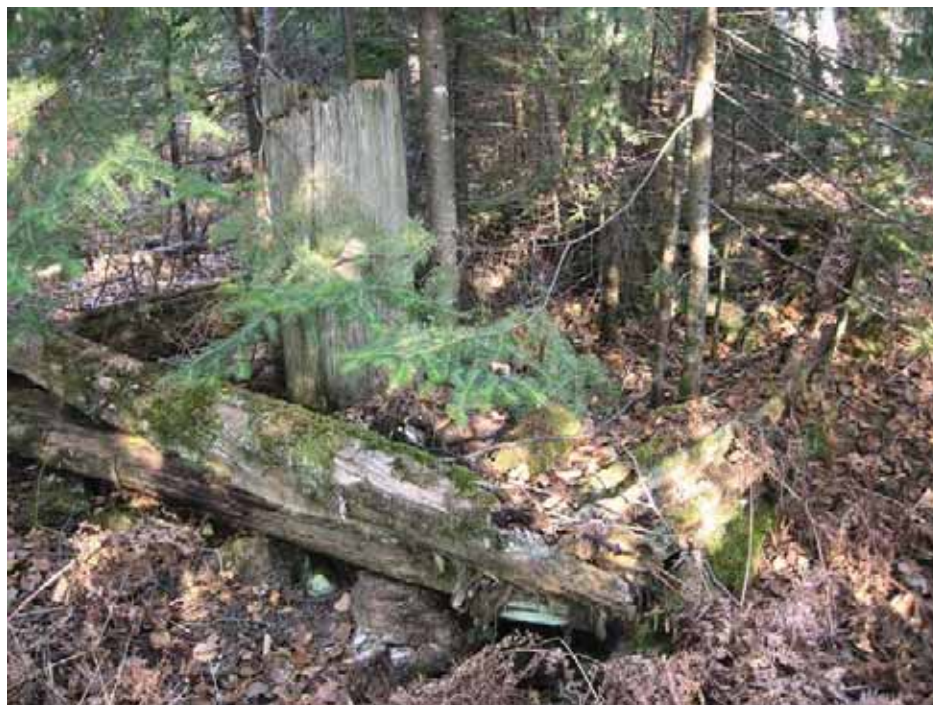
Figure 2.35. Photograph within the CPZ1 area showing an anchor pole support with cribbing.

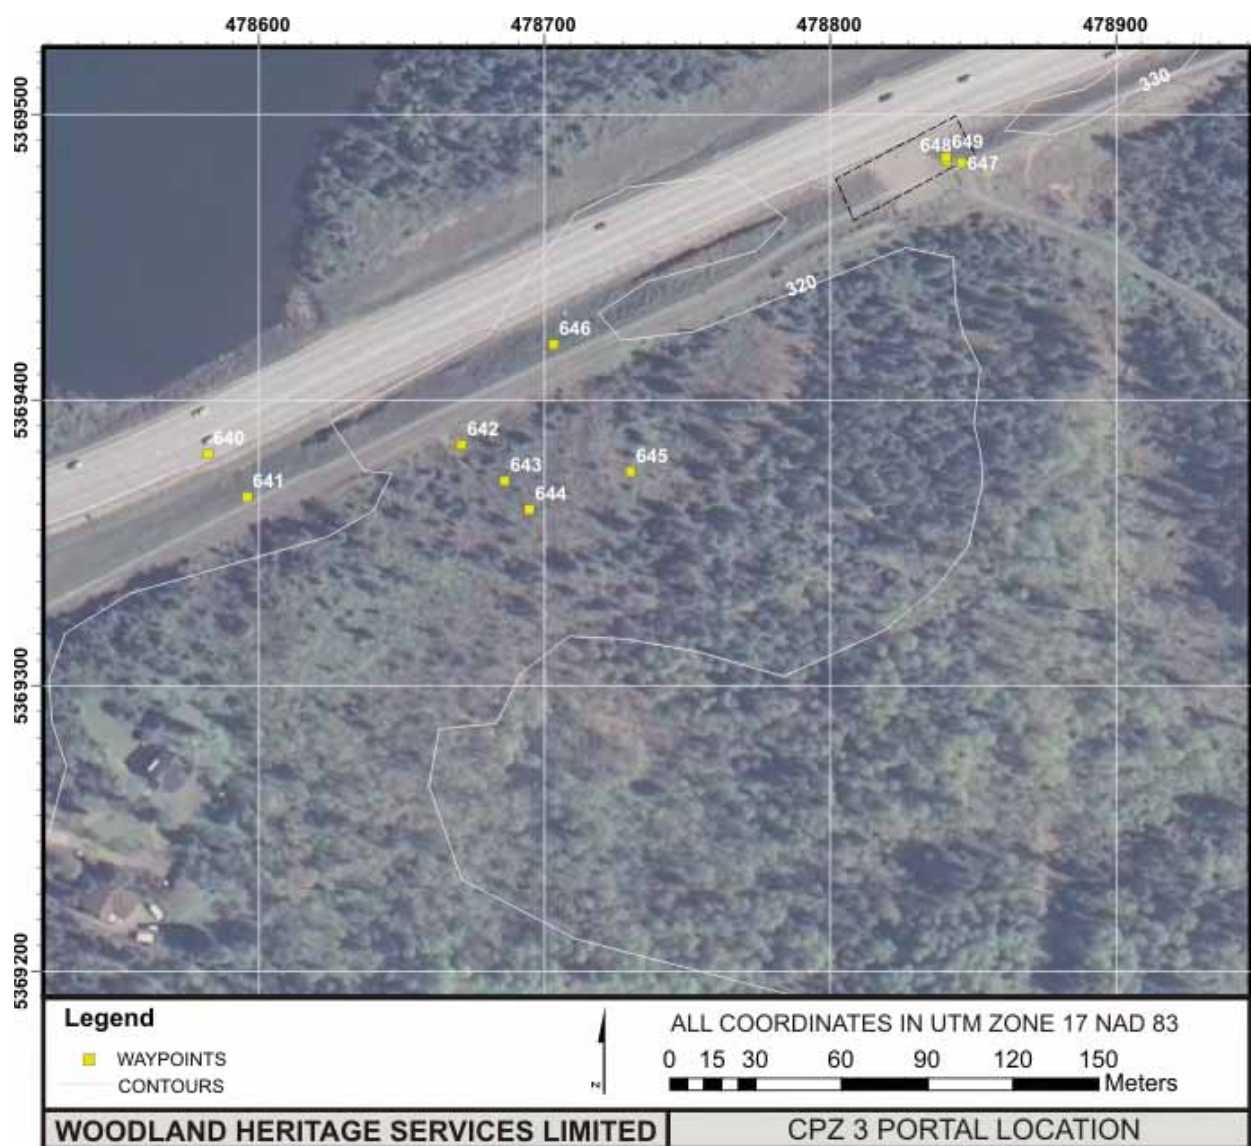
Figure 2.37. CPZ3 waypoints and satellite photo.

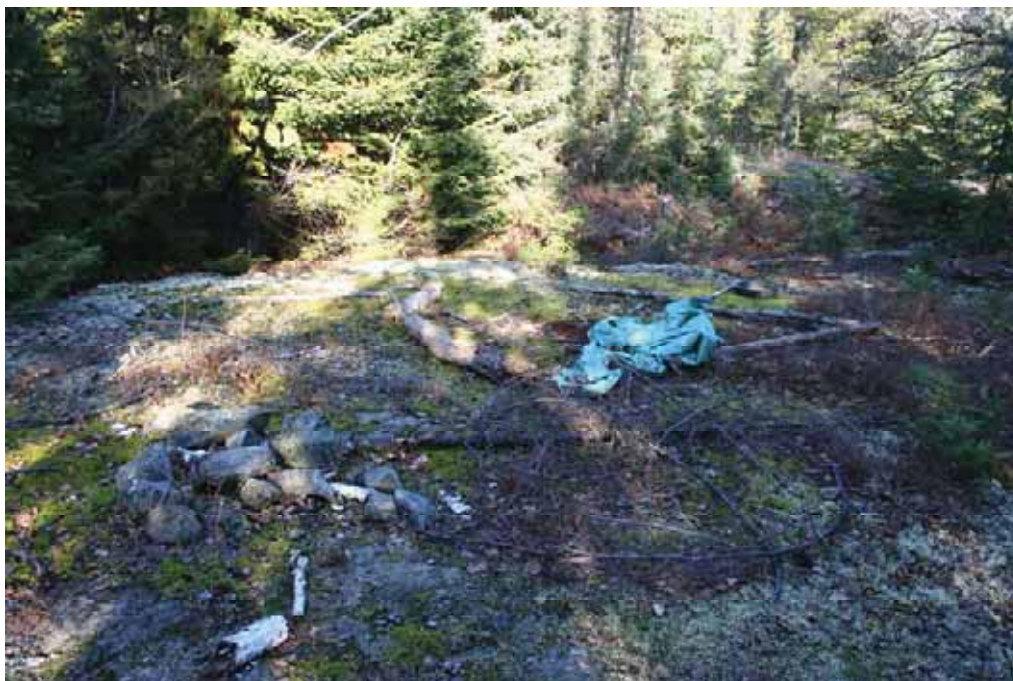
Figure 2.41. Small ephemeral camp. All materials observed were recent.

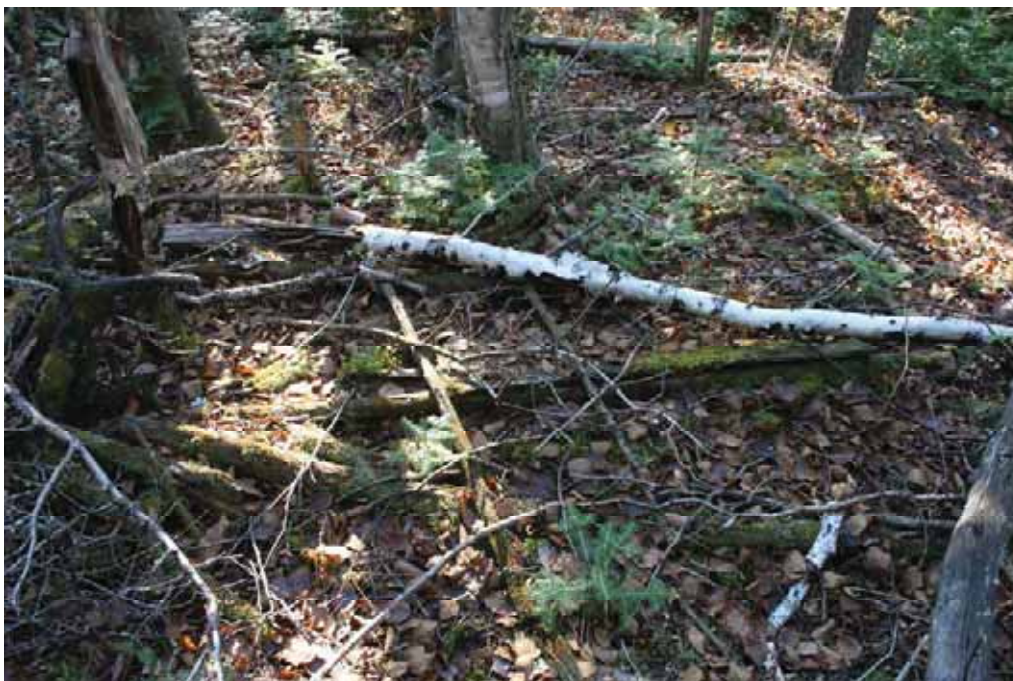
Figure 2.42. The other small campsite identified. Note the small platform/shelter.

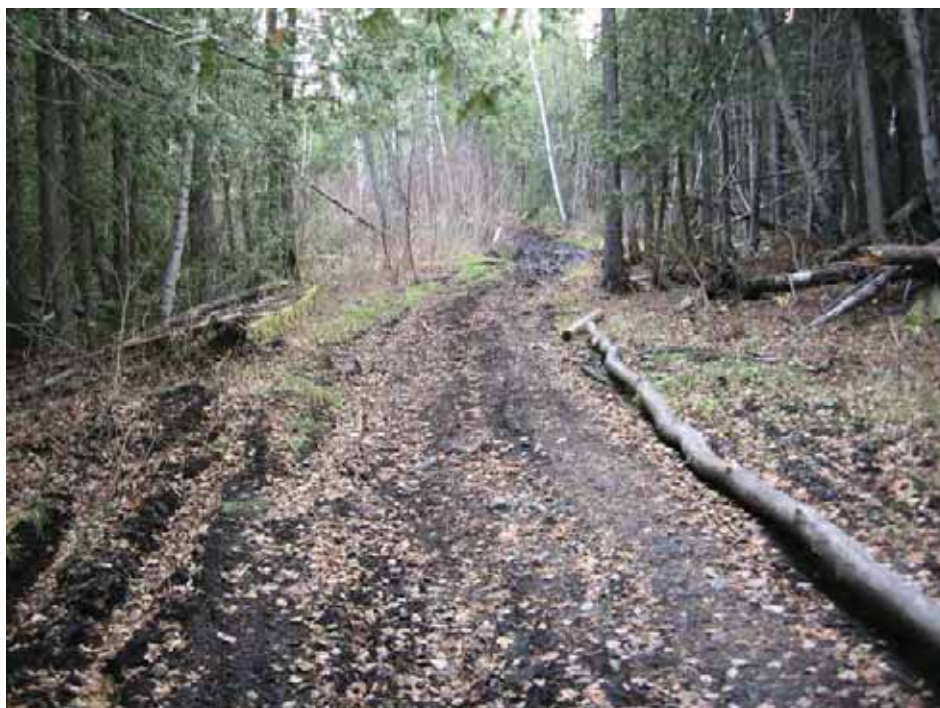
Figure 2.55. Photograph of a multi-use trail in the vicinity of the northern rock pile.

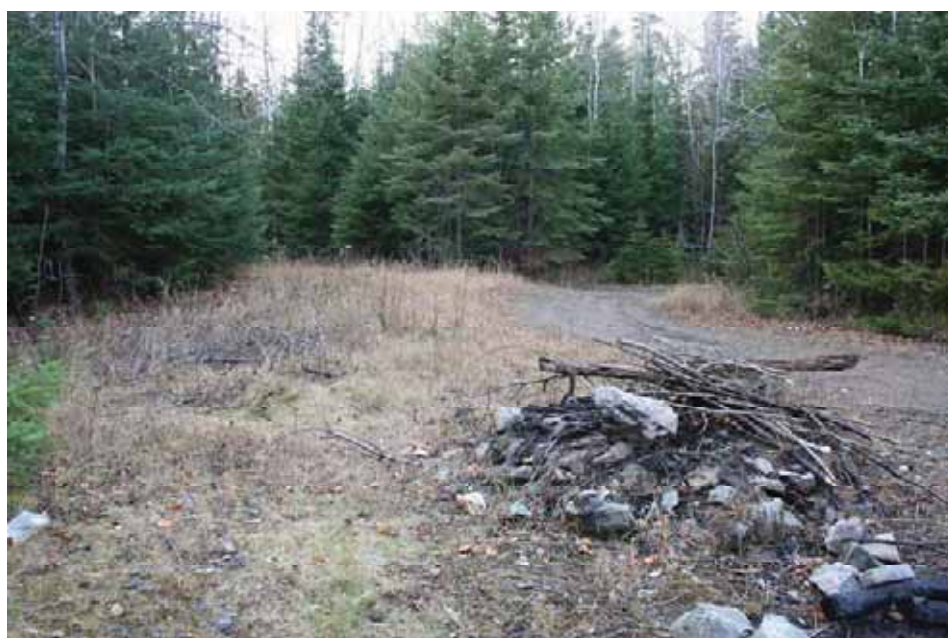
Figure 2.56. Photograph of a recent hearth and associated multi-use trail.
