**GOLDCORP CANADA LTD.  
HOLLINGER PROJECT**

**PRE-FEASIBILITY ENVIRONMENTAL BASELINE  
STUDIES**

**AQUATICS ECOSYSTEM EXISTING CONDITIONS  
REPORT**

**March 2008  
TC 71507**

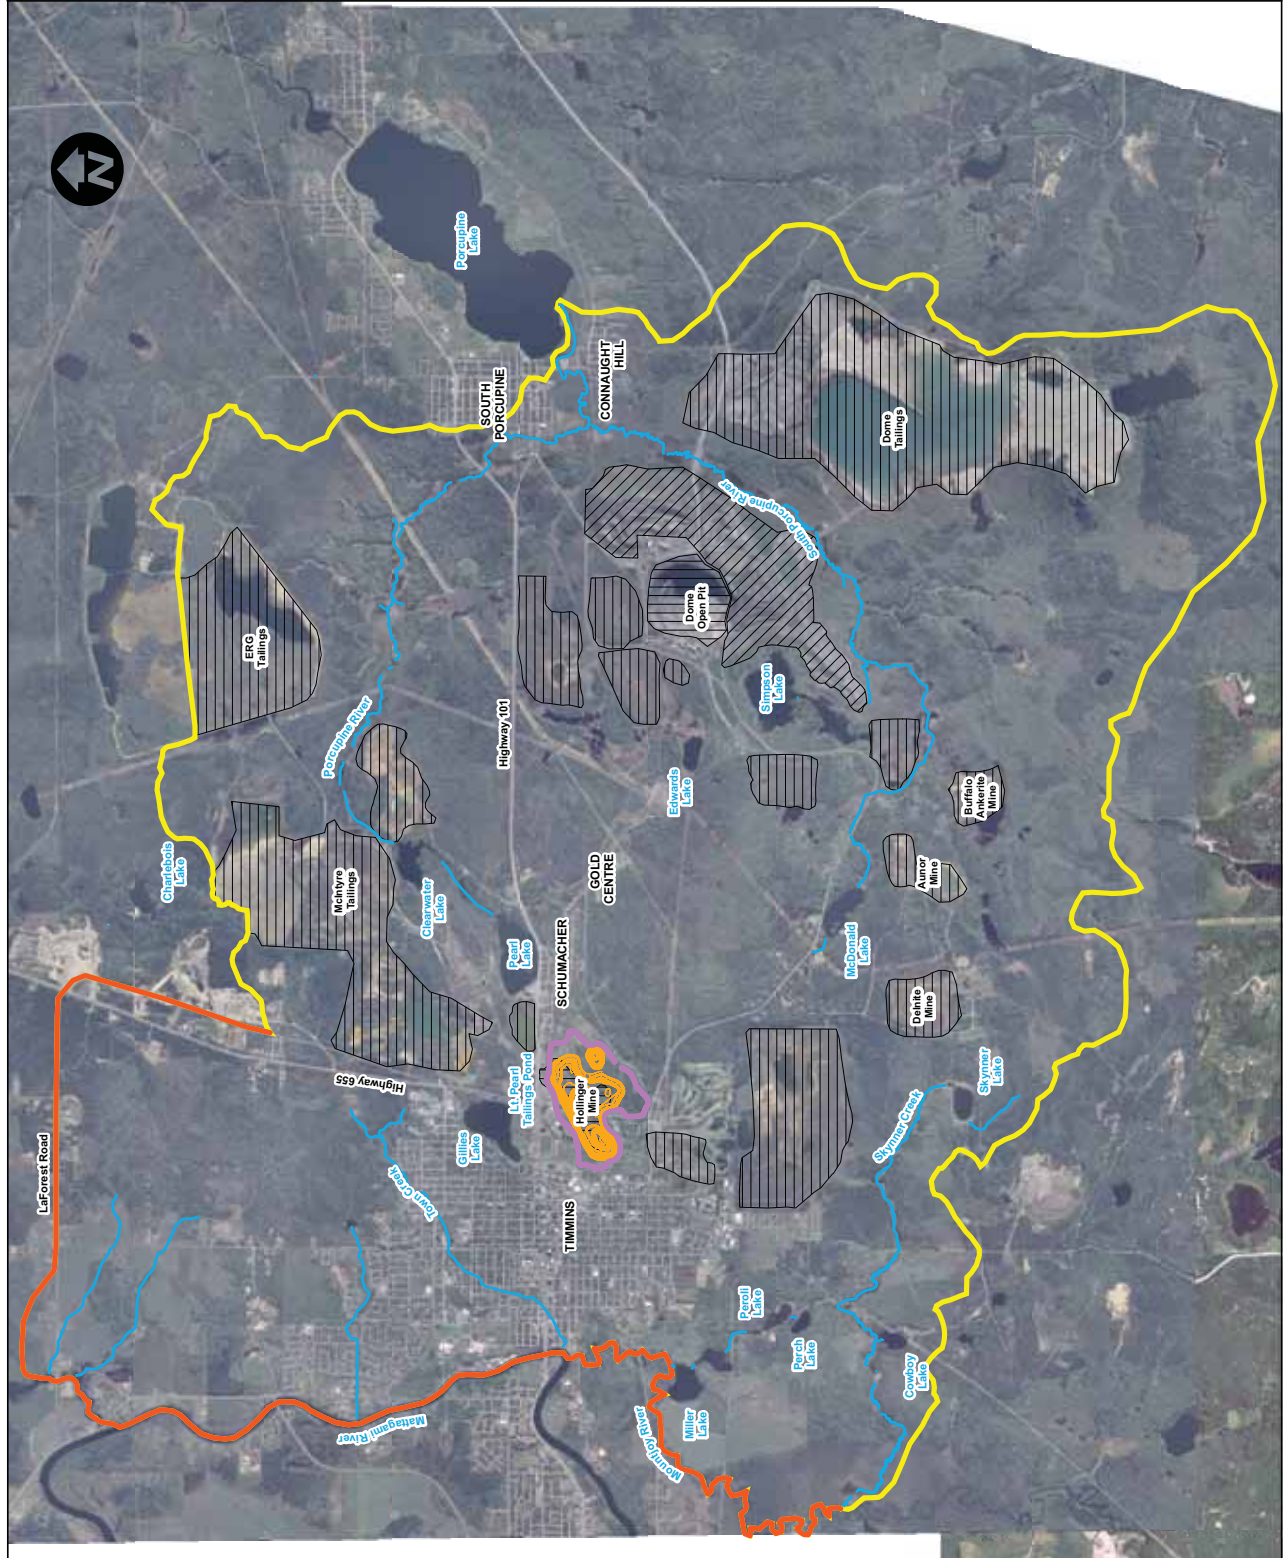
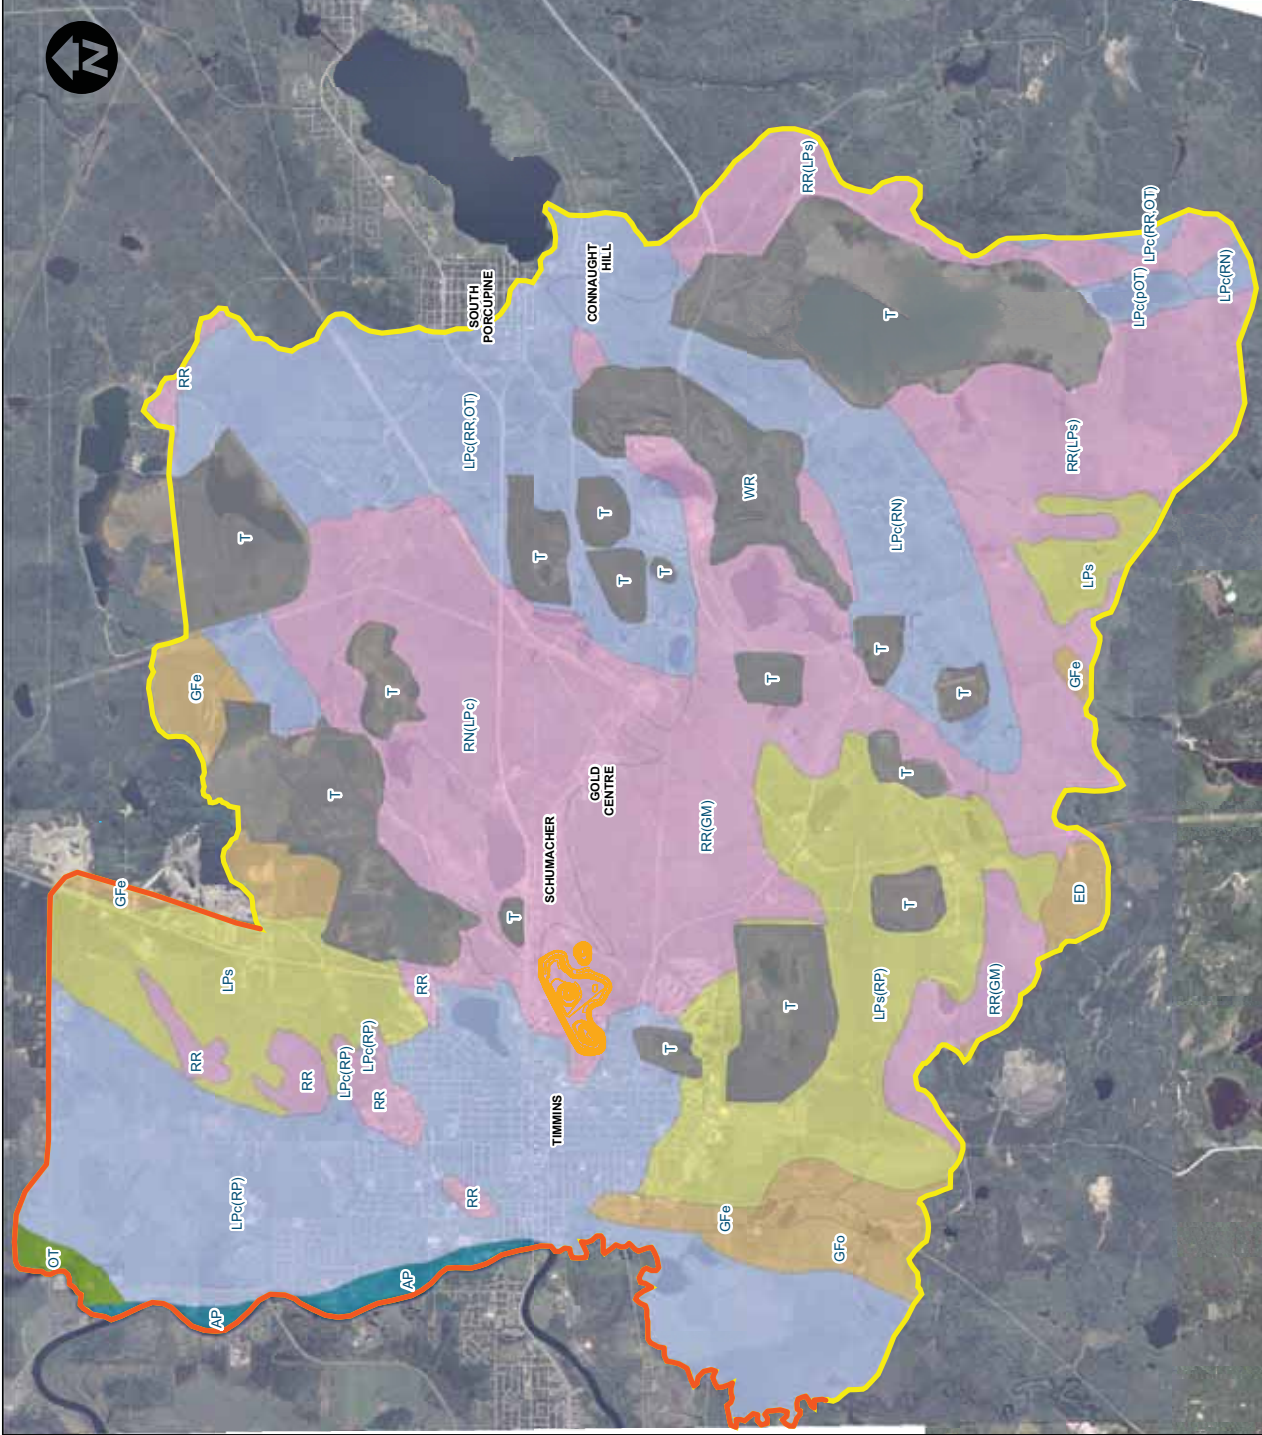
<b>HOLLINGER BASELINE STUDIES</b>	
TIMMINS	ONTARIO
<b>Site Location and Study Area</b>	
SCALE: 1:52,500	DATE: September 2007
PROJECT No: TC171607	FIGURE: 1.1
	REV: 2

- Study Area (Watershed Boundary)
- Study Area (Riverine and Road Boundary)
- Proposed Open Pit

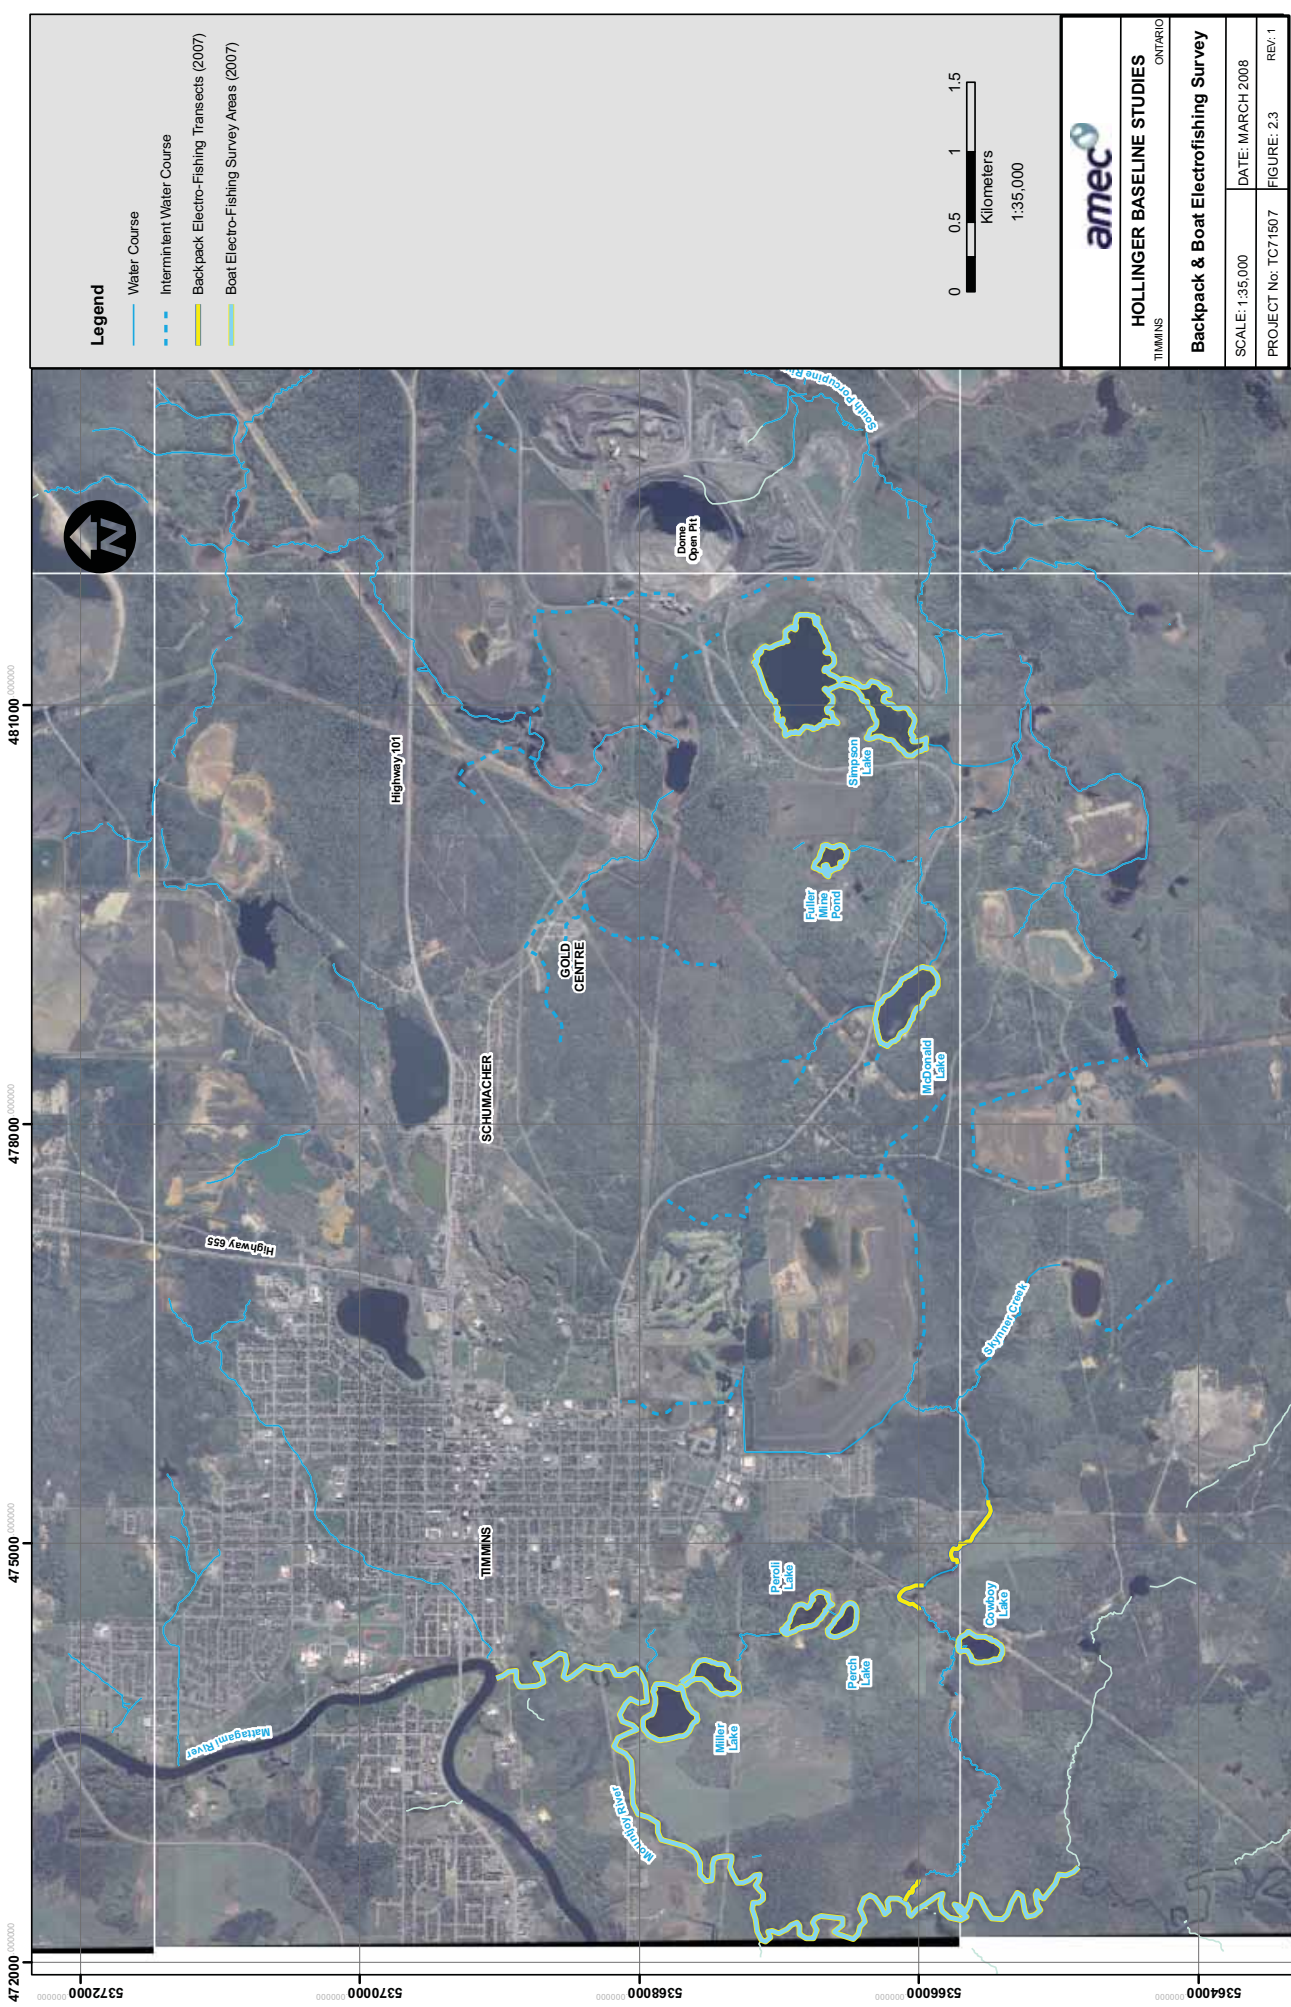
SCALE: 1:35,000	DATE: MARCH 2008
PROJECT No: TC71507	FIGURE: 2.3
	REV: 1

- Water Course
- - - Intermitent Water Course
- Backpack Electro-Fishing Transects (2007)
- Boat Electro-Fishing Survey Areas (2007)

Electrofishing was conducted where habitat and access allowed utilizing either a Haltec Backpack Electrofisher (Model Number HT2000B) or a Smith-Root boat electrofishing unit (Model No. 2.55 GPP Electrofisher System). Backpack electrofishing was completed in representative watercourse reaches in an upstream fashion. Electrofishing was typically conducted where defined channels were less than 1 m in depth and bed condition permitted safe wading and collection activity.

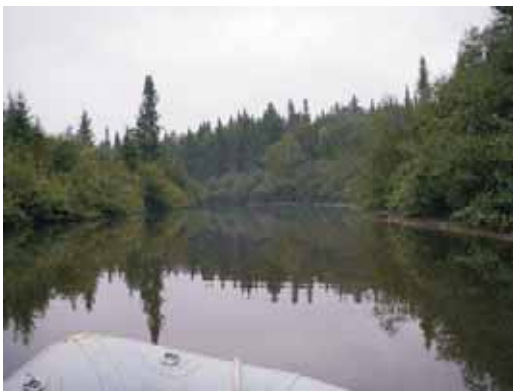
Mountjoy River

AVERAGE WIDTH = 26 m  
AVERAGE DEPTH = 3.13 m  
OVERHEAD COVER = 20%  
INSTREAM COVER = 20% - wood / vegetation / turbid water

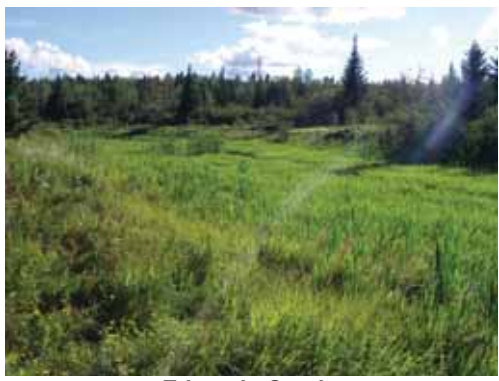
Edwards Creek

**AVERAGE WIDTH = 1.2 - 1.5 m**  
**AVERAGE DEPTH = 0.35 m**  
**OVERHEAD COVER = 30%**  
**INSTREAM COVER = 25% wood / vegetation / organics / undercut banks**

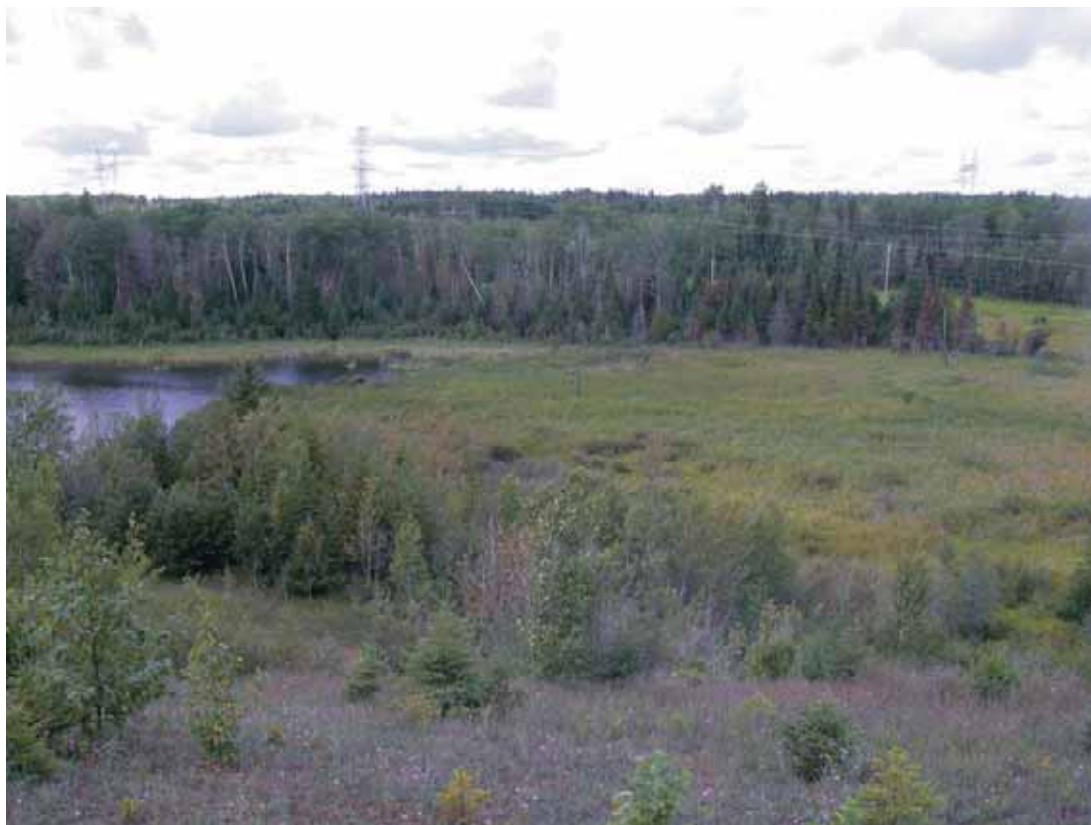
Edwards Creek South of Hwy. 101

**AVERAGE WIDTH = 1.72 m**  
**AVERAGE DEPTH = 0.78 m**  
**OVERHEAD COVER = 15%**  
**INSTREAM COVER = 15% wood / vegetation / urban debris / undercut banks**

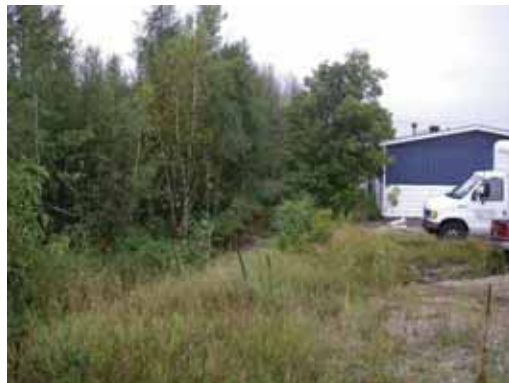
**Skyenner Creek**  
**Residential development**  
**adjacent to channel**

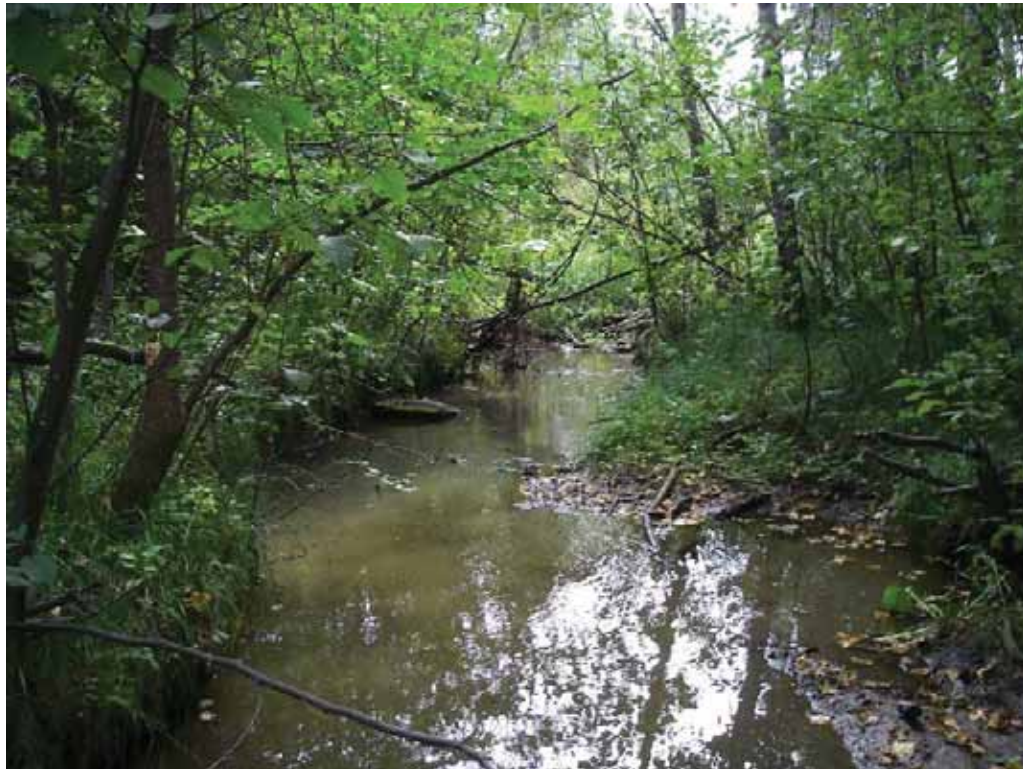
Skynner Creek at Pine Street

**AVERAGE WIDTH** = 1.60 m  
**AVERAGE DEPTH** = 0.60 m  
**OVERHEAD COVER** = 10%  
**INSTREAM COVER** = 35% - rock / wood / organics / undercut banks/ vegetation

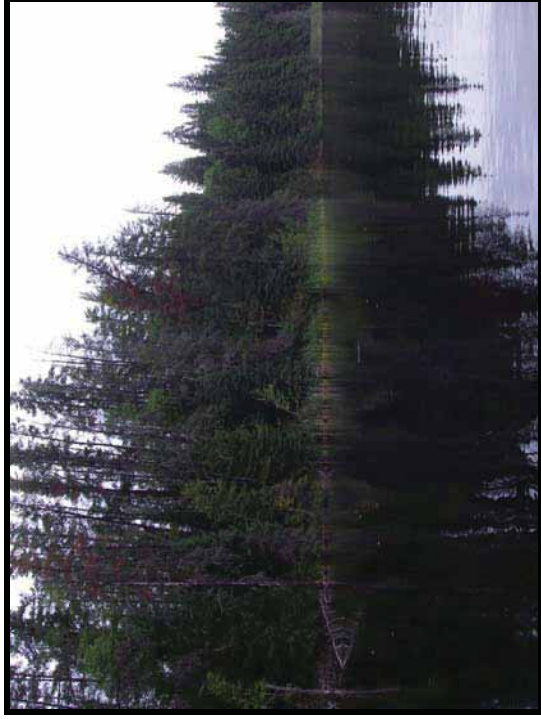
Cowboy Lake – Shoreline Type 2

Shoreline Habitat Type 2 is characterized by sparse wetland conditions typically in shallow water depths (<1 m) with soft organic substrate materials. Near shore emergent species consisting of grasses, sedges, and/or cattails are typical in low densities. Isolated distributions of submergent macrophytes, commonly stonewort, are generally interspersed throughout. Sporadic areas of floating vegetation are common such as yellow water lily, floating pondweed, or watershield. Beyond the typically flooded wetland margin, shrub and sapling species prevail. Overbank areas can exhibit a coniferous, mixed, or deciduous forest depending on adjacent terrain and soil conditions.

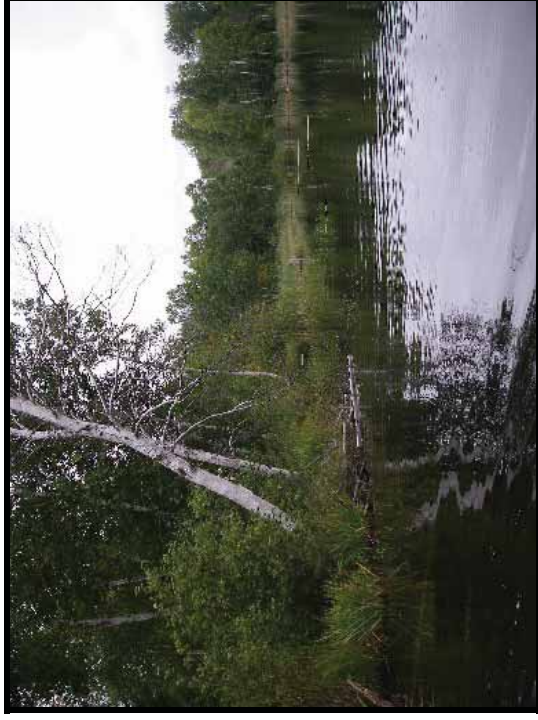
Perch Lake – Shoreline Type 1A

Reach Type 1 characteristically exhibits low gradients (<1.0%) and flat channel morphology. Channel diagnostic features are commonly uniform throughout with only minor variation in wetted depths and widths. Typically, wetted widths are greater than 5 m and flow velocities are low. These combined conditions permit deposition of variable sediment materials such as silt, fine sand, and organic detritus. Riparian margins are generally dominated by shrub species such as Red-osier dogwood and willow in association with an outer overbank assemblage of mixed forest species.

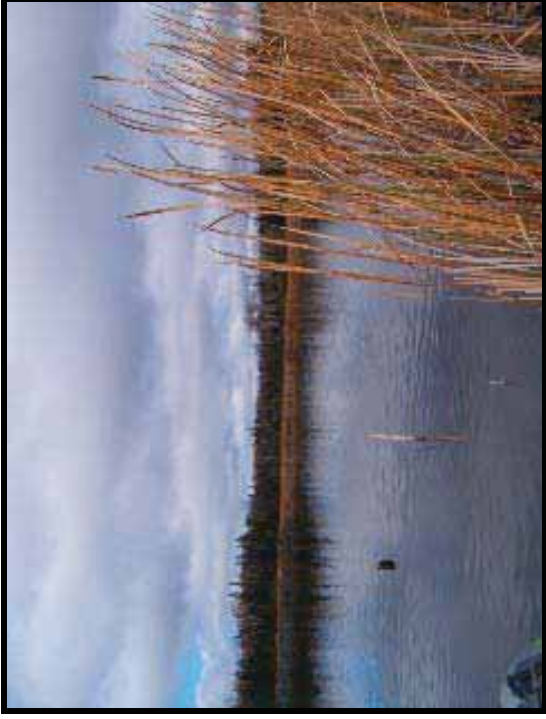
Fuller Mine Pond

Shoreline Type 2A Foreground- Shoreline Type 3 in Background

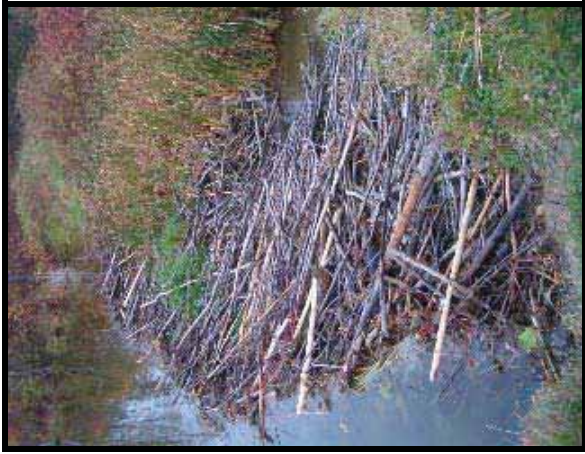
Beaver Dam Separating Miller Lake and Miller Pond

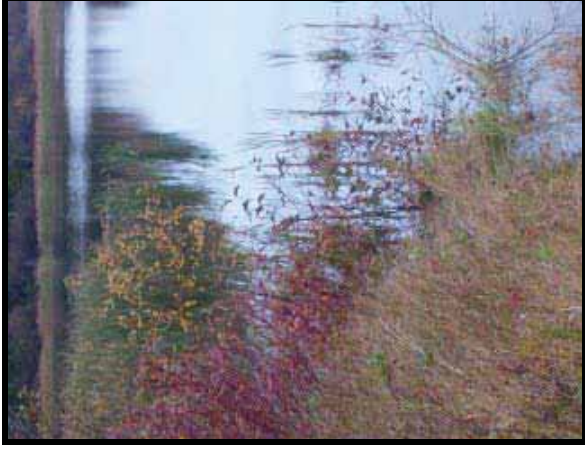
Miller Lake – Shoreline Type 3A

This shoreline habitat type represents areas that have been historically altered for various purposes such as roadway access, shoreline protection, or infilling for infrastructure installation (e.g., causeways, road embankments, pumphouse infills). Materials associated with this shoreline type include granular fill and bank and bed scour protection in the form of riprap. Generally, shorelines are devoid of vegetation due to nature of rocky fill, or riparian overhanging shrub and groundcover vegetation colonize the open voids within the fill material providing sporadic areas of coverage. Additionally, this habitat type does not normally include a supralittoral area due to the nature of the structure's usage. Aquatic vegetative community diversity and density can vary and is largely dependant on the age of the existing structure and deposition of sediments on placed substrates that permit recolonization.

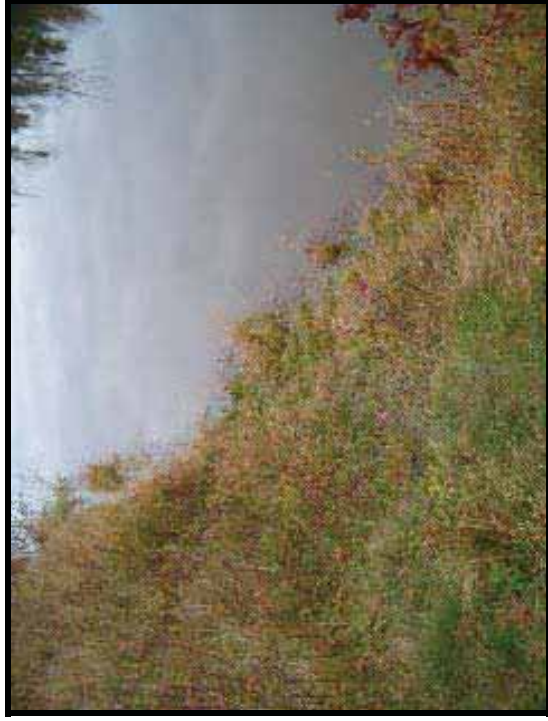
Miller Lake – Shoreline Type 3A
